Comparative Study of Performance between International Roughness Index (IRI), Pavement Condition Index (PCI), and Bina Marga Method on Roadways

St. Maryam H [1, *], Bulgis [1], Rustam Madami [2]

This study was conducted on the national road section of SP. Jambula - SP. Dufa-Dufa (from Jambula intersection to Dufa-Dufa intersection) in Ternate City, North Maluku Province, Indonesia. The location was chosen for research because the SP Jambula - SP Dufa road section is the longest national road in Ternate city, as seen in Figure 1, and it surrounds the city of Ternate, making it an important land transportation area in the city. This makes it a desirable location for identifying and analyzing road damage conditions.

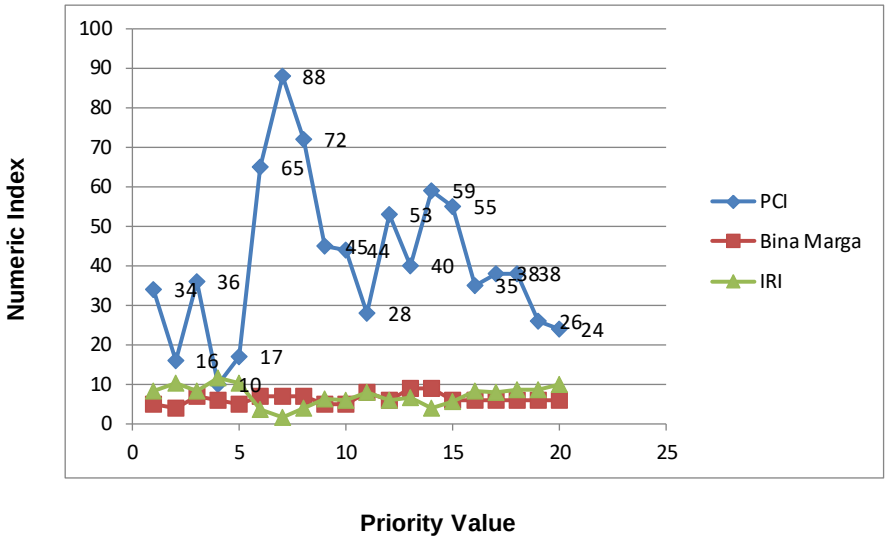
Figure 5. Relationship Graph of PCI, IRI, and Bina Marga Methods : Sp.Jambula – Sp.Dufa-Dufa Road, Ternate, North Maluku, Indonesia

Based on the identification results from Tables 10, 11, and 12, as well as Figure 5 of the three methods, namely IRI, PCI, and the Bina Marga method, several conclusions can be drawn that the road conditions vary from poor to good. From the graph results in Figure 5, it is evident that the Pavement Condition Index (PCI) method shows an inverse assessment pattern compared to the assessment graph of road conditions using the International Roughness Index (IRI) and Bina Marga methods. The International Roughness Index (IRI) provides an indication of the level of road surface roughness. The IRI results show that there are damaged sections of the road, both in the category of light and severe damage. However, the majority indicates that the road section falls into the moderate category. The Pavement Condition Index (PCI) provides an overall assessment of the road surface condition. The PCI values indicate that the majority of the road sections experience poor or fairly poor conditions, although there are some sections that show good or very good conditions. The Bina Marga method provides classification based on the level of road maintenance needs. In this case, the majority of the values require routine maintenance, with some values requiring periodic maintenance and road improvement.

It is important to consider other methods, such as the Bina Marga method and the PCI method, together with the IRI method to get a more complete picture of pavement conditions. For example, in STA 00+00-00+100, the PCI method calculates potholes with a density value of 0.43%, then the Bina Marga method calculates the value 0 because it is not included in the range (10 > 30%). Of course, this is what makes the calculation difference between the analysis of the PCI method and the Highways.

Based on research result, it is recommended to use a maintenance program based on the results of the Pavement Condition Index method because the PCI method has a more detailed and objective analysis regarding all aspects of the damage (Faisal et al., 2021; Ramadhan et al., 2020). In line with research (Ayu et
